## Case Study: Treig Dam

### Physical Model Testing of Spillway for Halcrow Water

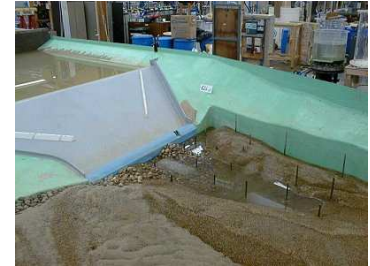
Treig Dam is a rockfill embankment dam approximately 12m high. The spillway is located on the embankment with the spillway crest formed by the top of the core wall. The flow passes down the spillway over concrete slabs cast directly on the rockfill, which forms the sloping downstream face. The width of the spillway decreases from 100m at the crest to 45m at the roller bucket along the toe. Side training walls and baffle walls are used to guide the flow down the spillway.

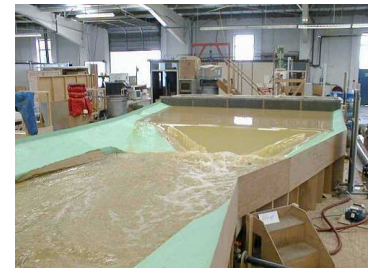
- Original design flood peak outflow 215m<sup>3</sup>/s but recent estimates indicated PMF 624m<sup>3</sup>/s
- Flood Stability Assessment Report raised concerns that high flood flows could cause excessive erosion at the toe of the spillway resulting in:
  - failure of protective sheet pile wall beneath the toe of the dam
  - loss of embankment fill from beneath the concrete slabs
  - endangering the structural integrity of the dam.

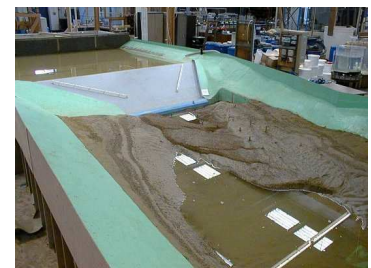
A 1:30 scale model of the Treig Dam was constructed to assess the performance of the spillway at a range of discharges up to the equivalent to the 1 in 10000 year peak flood and the Probable Maximum Flood (PMF). The installation of a mobile bed section enabled the extent and magnitude of the erosion of the downstream terrain to be investigated.

A rockfill apron positioned immediately downstream of the roller bucket was found to prevent severe erosion of the bed material local to the spillway at discharges up to the PMF. This ensured that a sheet-piling wall previously installed along the toe of the spillway would be protected. Structural modifications were recommended to contain the flow within the confines of the spillway.
